5.3 Reach 1

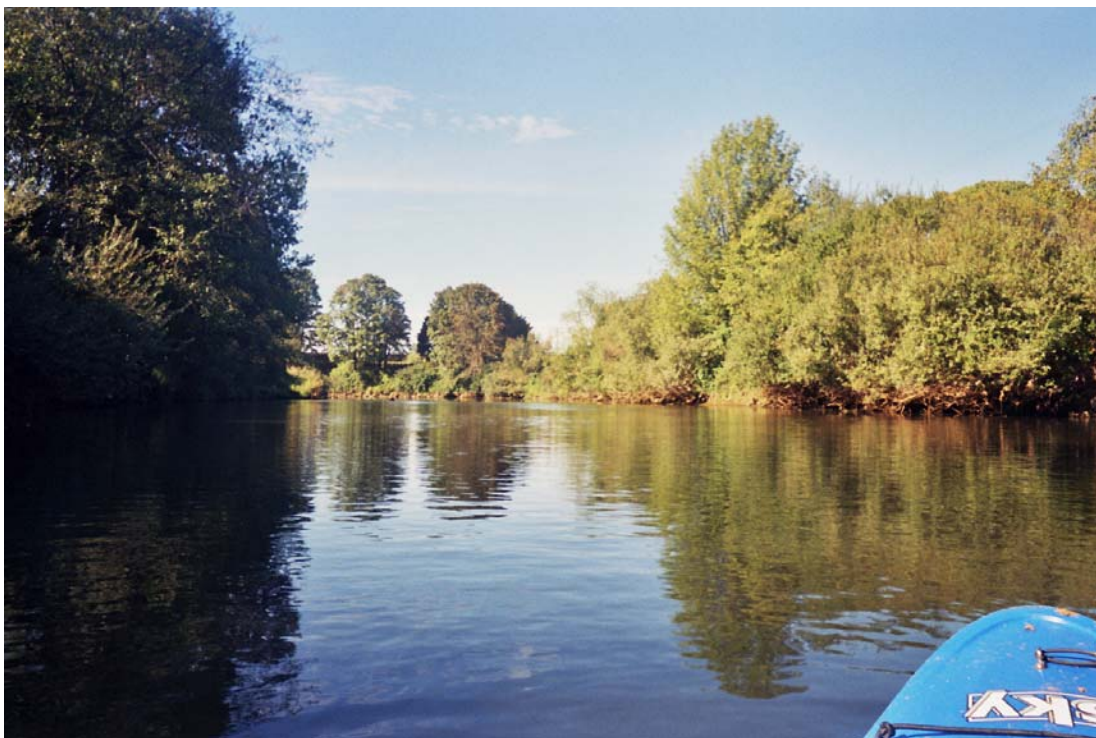
Photo 5-1. Typical Reach 1 conditions, Stations 26 through 30, facing downstream, showing high quality riparian vegetation in the foreground and less abundant riparian vegetation downstream, where a road embankment constrains the right bank.

Surveys of Reach 1 (RM 32.1 – 26.6) were completed on September 9 through 12, 2003. Reach 1 has relatively high quality riparian vegetation on at least one bank for almost its entire length (Photos 5-1 and 5-2). In the upper portion of the reach, high quality vegetation occurs along the right bank, whereas in the lower portion of the reach, more high quality vegetation occurs along the left bank (see Figure 5-4). The river in this reach is naturally constrained on the right bank by the east valley wall and by road embankments. The left bank is less constrained in the downstream portion of Reach 1 compared to the upstream portion where the river flows through an agricultural area. Woody debris and gravel both appear to be moving through the reach. Large black cottonwood trees (*Populus trichocarpa trichocarpa*) directly adjacent to the river provide potential for future wood recruitment (Photo 5-3). Reach 1 contained only one dock, located at Station 1-20.

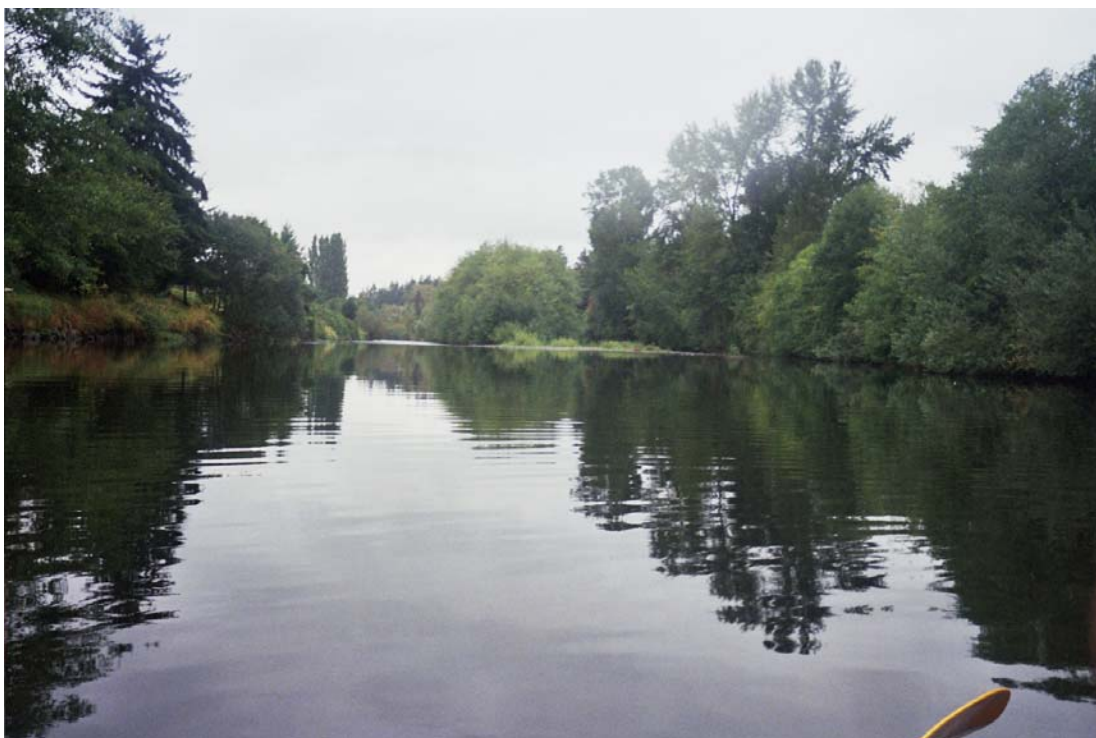
Photo 5-2. Typical Reach 1 conditions, near Station 12, facing downstream, showing a mid-channel island with a vegetated gravel bar.

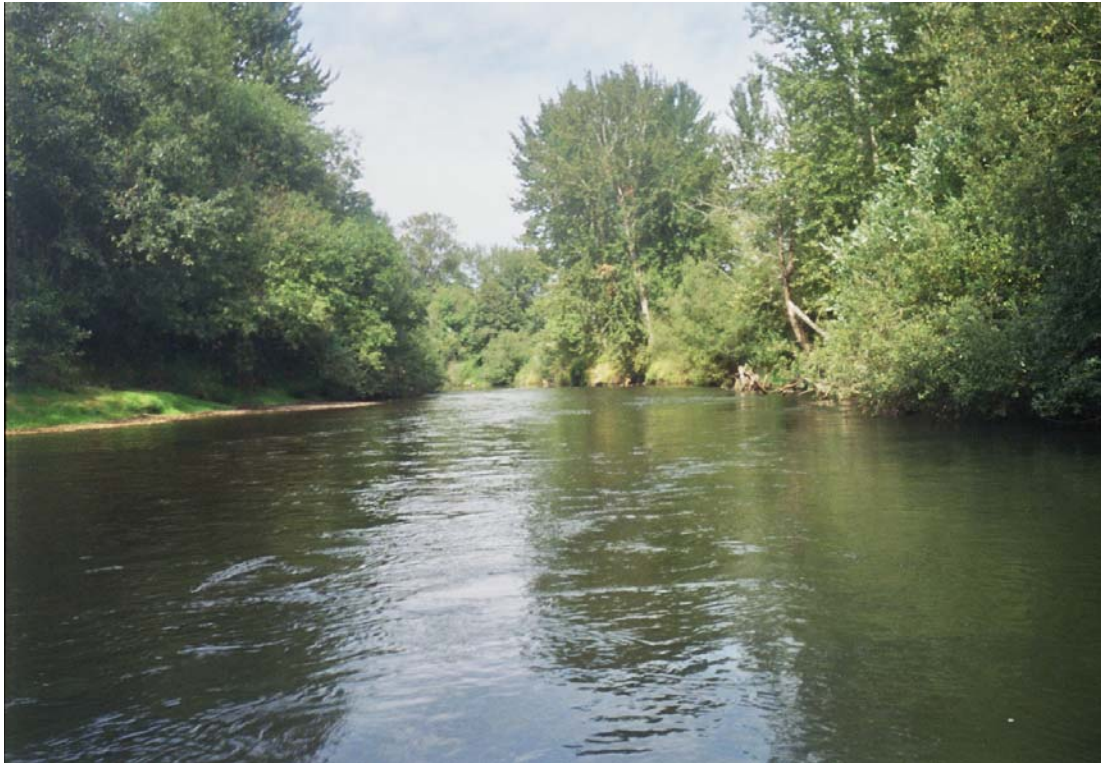
Photo 5-3. Black cottonwood trees and terraced floodplain near Reach 1, Station 30.

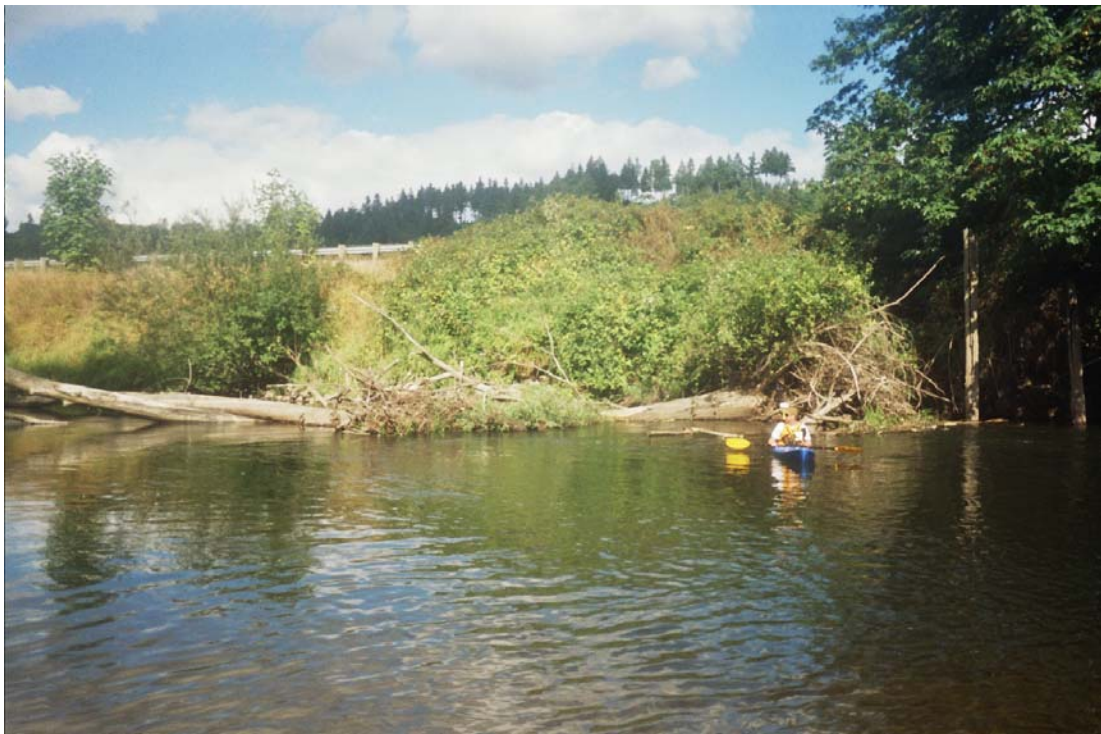
Photo 5-4. Representative lateral scour pool in Reach 1.

Table 5-1 summarizes habitat information collected in Reach 1. The total length of this reach was 5.5 miles (8.9 km) and glides were the dominant habitat type. The mean OHWM width was 39 m, and the mean wetted width was 33 m. A total of 18 pools were identified in this reach, including large and small pools, yielding an average of 2.5 pools per mile, and an average pool frequency of 13 channel widths between pools (CW/pool; where channel width = OHWM width) (Figure 5-8). The dominant pool-forming feature of most of the large pools in Reach 1 was riprap (11 of the 14 pools, 79 percent); one pool was formed by mid-channel scour directly downstream of a large gravel bar, and one was formed by wood. A representative photo of a lateral scour pool found in Reach 1 of the Lower Green River is provided as Photo 5-4.
